# **.50 Caliber FSP Test**

**11 January 2008**

**Bastogne Manufacturing LLC**

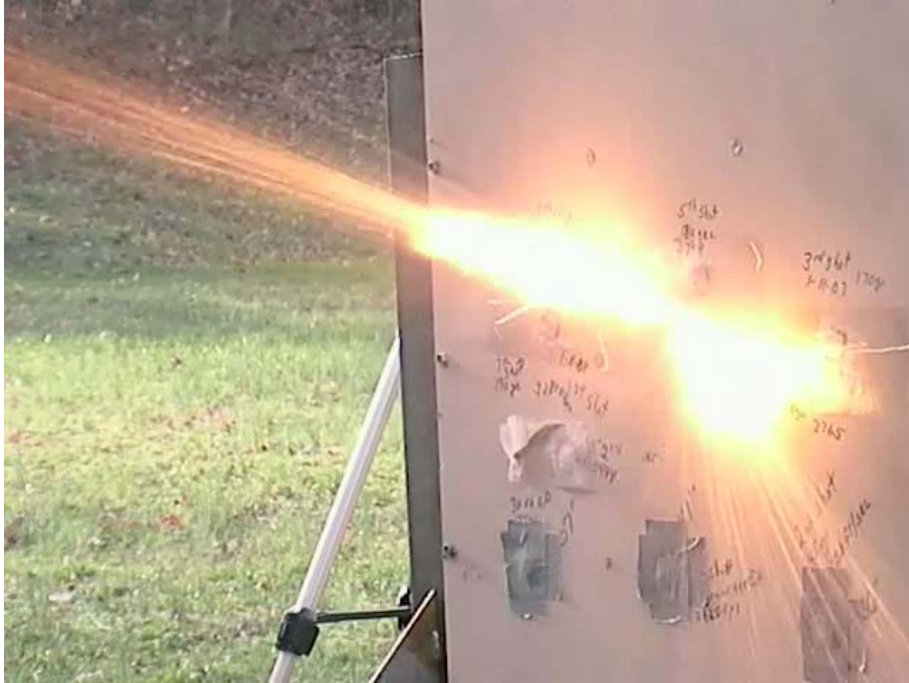
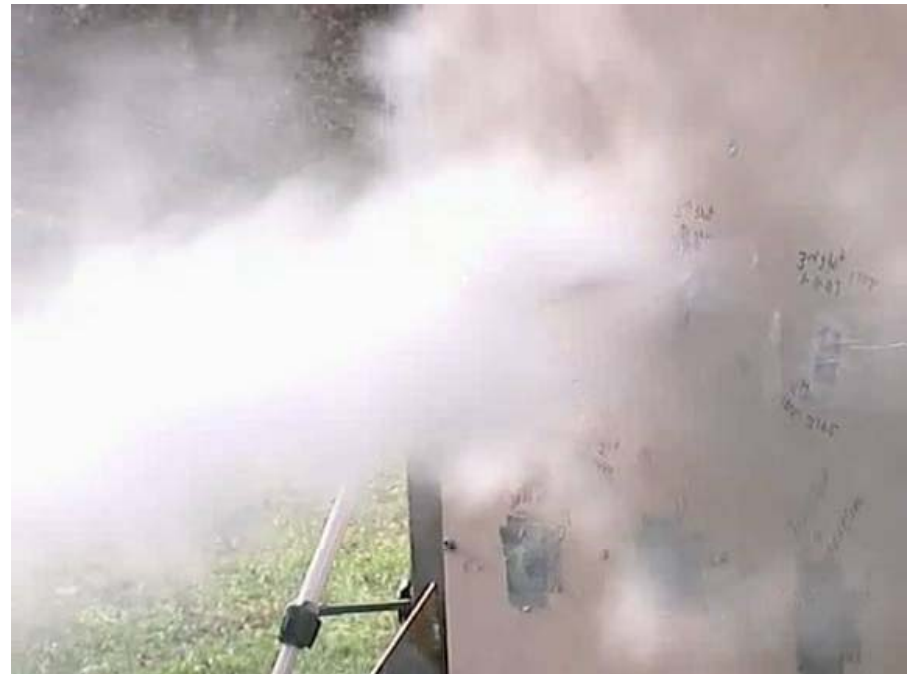
FSP striking outer panel; sand blow back as FSP enters 1<sup>st</sup> sand filled cavity

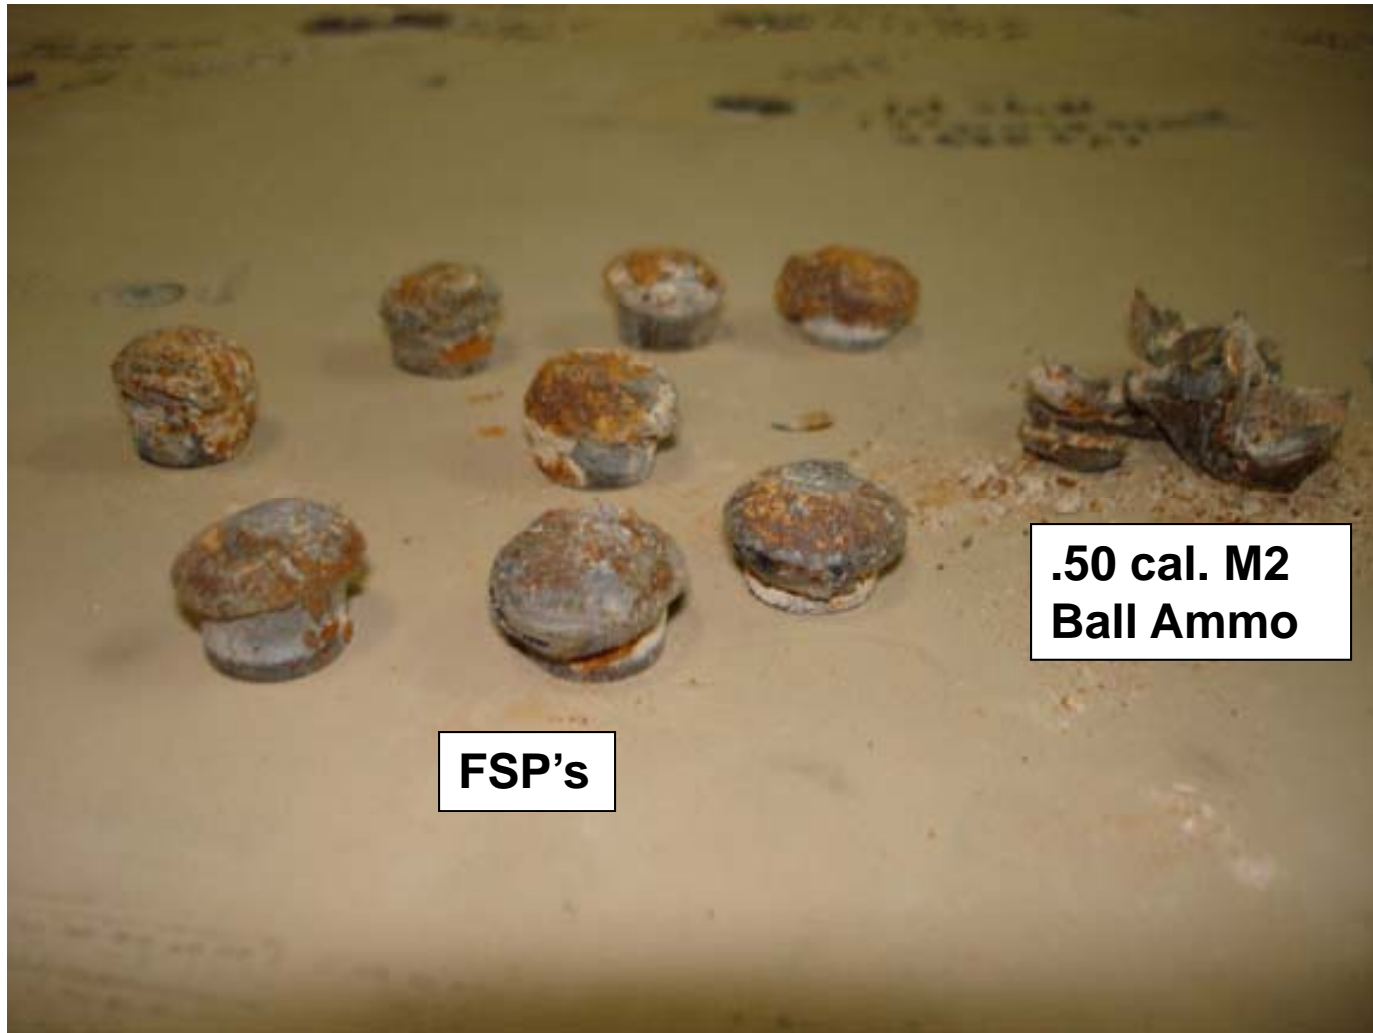
# Recovered FSP's and Bullet

FSP's

.50 cal. M2  
Ball Ammo

Shot #1	150 grains - 3280 ft/sec	FPS stopped in first cavity, did not exit wall
Shot #2	160 grains - 3444 ft/sec	FPS stopped in first cavity, did not exit wall
Shot #3	170 grains - (chronograph error)	FPS stopped in first cavity, did not exit wall
Shot #4	170 grains - 3765 ft/sec	FPS stopped in first cavity, did not exit wall
Shot #5	180 grains - 3798 ft/sec	FPS stopped in first cavity, did not exit wall
Shot #6	190 grains - (chronograph error)	FPS stopped in first cavity, did not exit wall
Shot #7	190 grains - 4100 ft/sec	FPS stopped in first cavity, did not exit wall
Shot #8	200 grains - (chronograph error)	FPS stopped in first cavity, did not exit wall
Shot #9	M2 Ball Round - Military Issue - Lake City	Bullet stopped in second cavity, did not exit wall
